Rubbing salt in the wound

The presence of chloride and nitrate salts in a building may not be caused by rising damp, says Mike Parrett, but may come from any number of other sources – from soot and detergents to animal urine and fertilisers

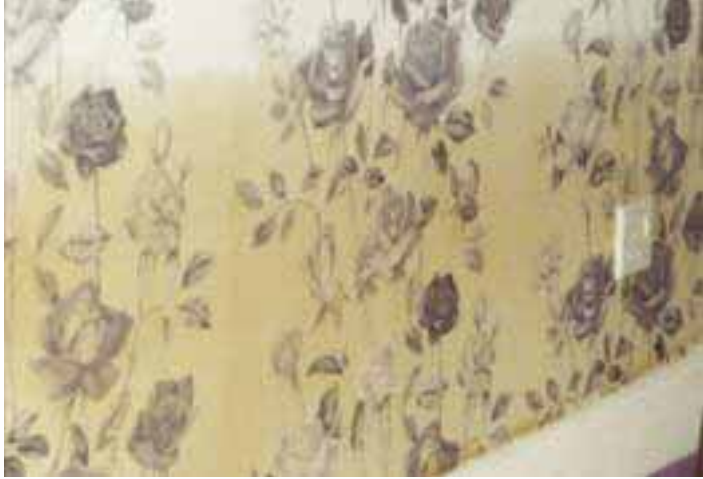
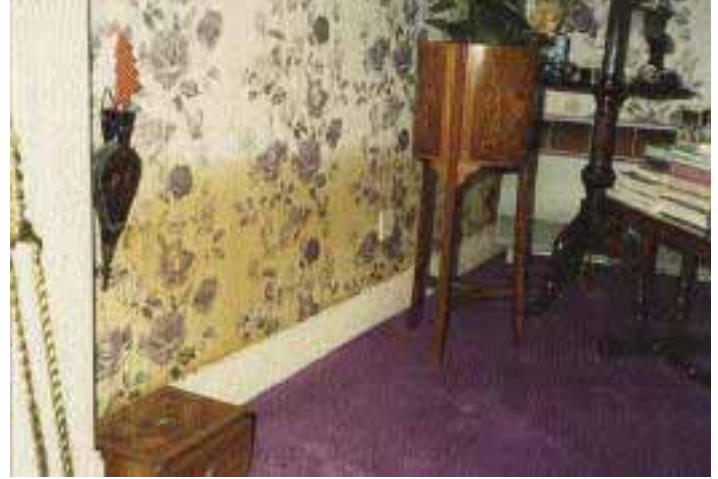
Both images © BRE, reproduced with permission

The 2007 edition of Digest 245 says this is a wall with rising damp (left image) but BR466 *Understanding dampness* says this is not a case of rising damp (right image) but is due to animal urine

- The photograph used on the front cover of the updated 245 (indicating “Staining to wallpaper on a wall affected by rising damp”) appears to be the same one used in a case study in *Understanding dampness* (page 191), which says it is not a case of rising damp, but a stain caused by animal urine (known to contain chloride and nitrate salts) likely to have arisen from the previous use of the building as a stable block (see above images). Interestingly, the same author is connected to both publications.
